Big Pipe Restores Function to Levee, Protects Florida Wetlands

St. Johns River Water Management District, Fellsmere, FL

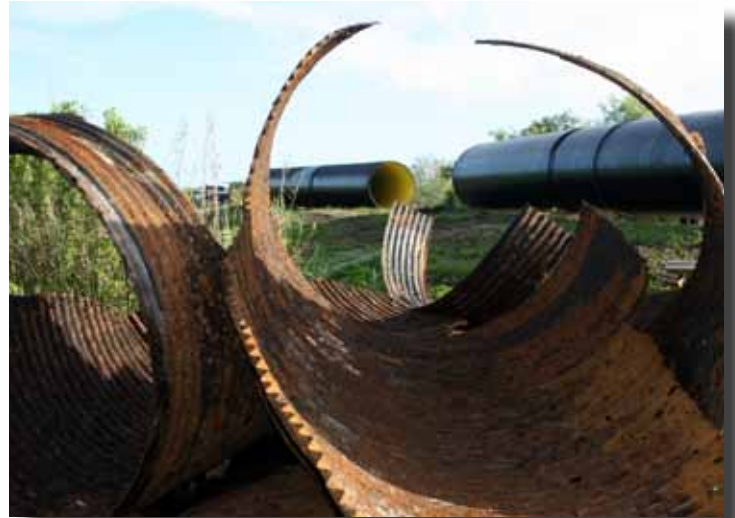
A view of the excavated deteriorated corrugated metal pipes with the new profile wall pipe liner in the background.

These corroded corrugated metal pipe culverts were installed 22 years ago by the United States Army Corps of Engineers, and did not last as long as expected. The district, as the levee sponsor, was responsible for the current repairs. The district needed an economical solution. Completely replacing the structure would have required a considerable time period during which the structure was not available. This would threaten the wetlands during the dry season when water needs to flow through the structure in order to feed into the wetlands. Sliplining the pipes eliminated the need for temporary cofferdams and de-watering, thus reducing the environmental impact of the construction.

The material chosen to reline the pipe was 60-inch diameter ProCor profile wall pipe manufactured by Profile Pipe Technologies (PPT) and supplied by ISCO Industries.

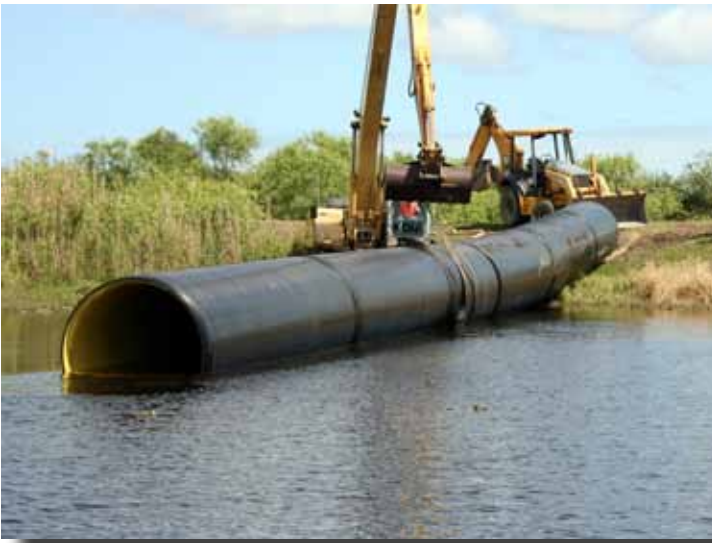
The electrofused PPT pipe was placed in the water to be submerged under water and pushed into the old pipe.

The PPT profile wall pipe, once it was fused and tested, was placed into the water with the aid of two of Shenandoah's divers. The divers then helped guide and submerge the pipe underwater.

The divers pushed and slipped the new pipe into the old pipe, stopping short of the flood gates.
