Paper Mill Replaces Steel Pipes with HDPE, Uses In-Ditch Fusion Machine for Timely Installation

Quinnesec, Michigan

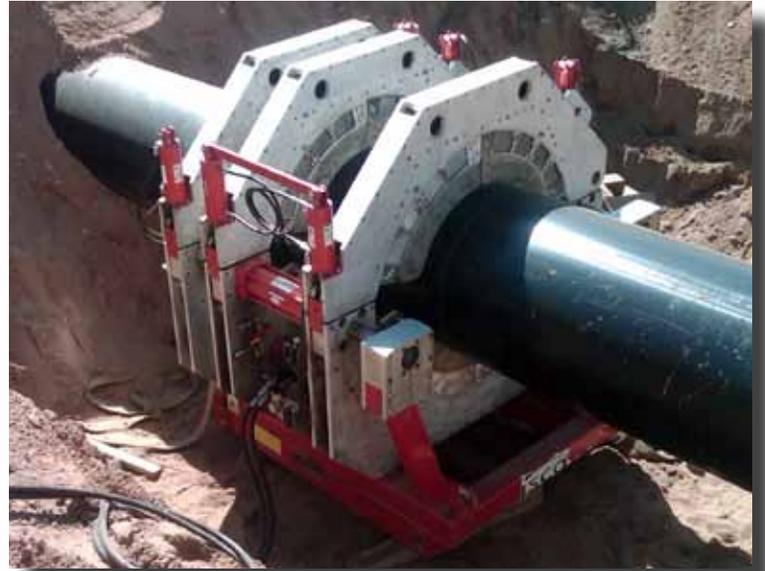
The 'Fire in the Hole' unit used to fuse pipe inside a compact trench.

In addition to supplying a McElroy #1648 fusion machine, ISCO had another solution, its in-ditch 'Fire in the Hole' unit. The unit is an alternative to large diameter electrofusion couplings that are used to fuse and repair pipe in tight places and ditches. However, couplings are not always the best choice because they can be expensive and come with some installation risks.

Until the 'Fire in the Hole' unit was developed, there was no American-made butt-fusion unit with this pipe size range available that was compact enough and capable of doing this type of work, especially in the ditch.

The custom-built 'Fire in the Hole' unit is unique because of how it is arranged to fuse pipe and fittings. The unit works in both three- and four-jaw configurations. The three- or four-jaw configuration is powered by a hydraulic power unit (HPU) and comes with a facer and heater(s) that are top loaded into the jaw set for operation. Capable of fusing pipe ranging from 32- to 54-inch IPS diameters, the unit also has McElroy Datalogger capabilities along with proven McElroy controls. This unit has many other features and benefits that make it in-ditch/trench friendly.

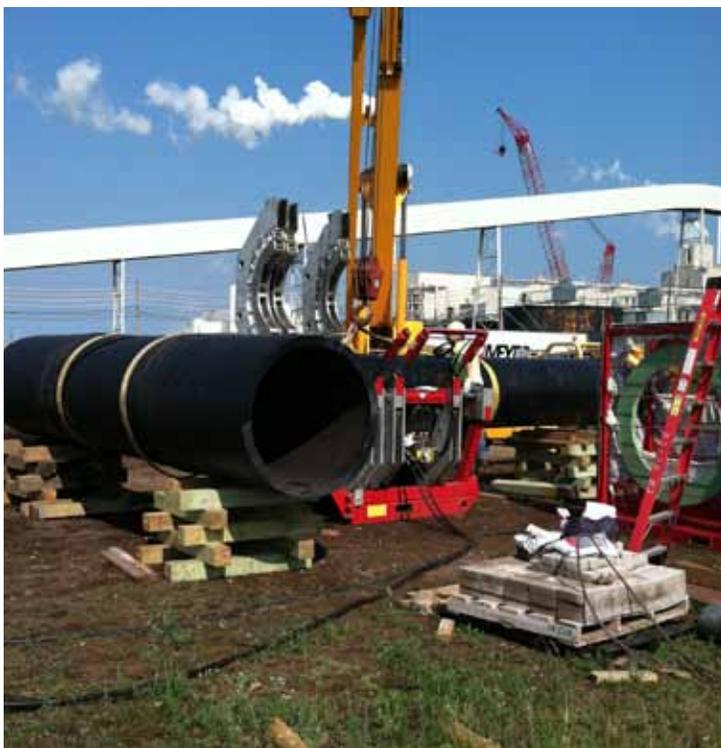
'Fire in the Hole' unit along with pipe on location.

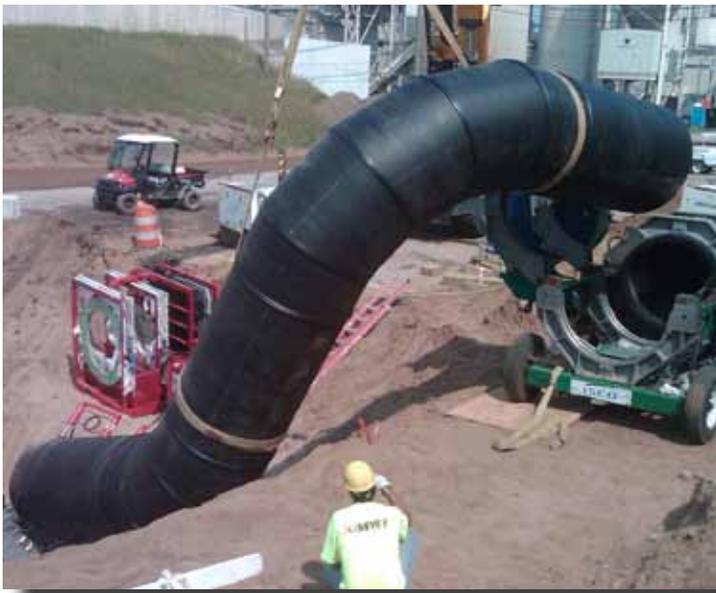
An example of a complex spool piece fabricated on site.

to the project site for one month. The technicians helped custom fabricate the spool pieces on site that were necessary for the completion of the system. The technicians also assisted the contractor in the use of the 'Fire in the Hole' unit.

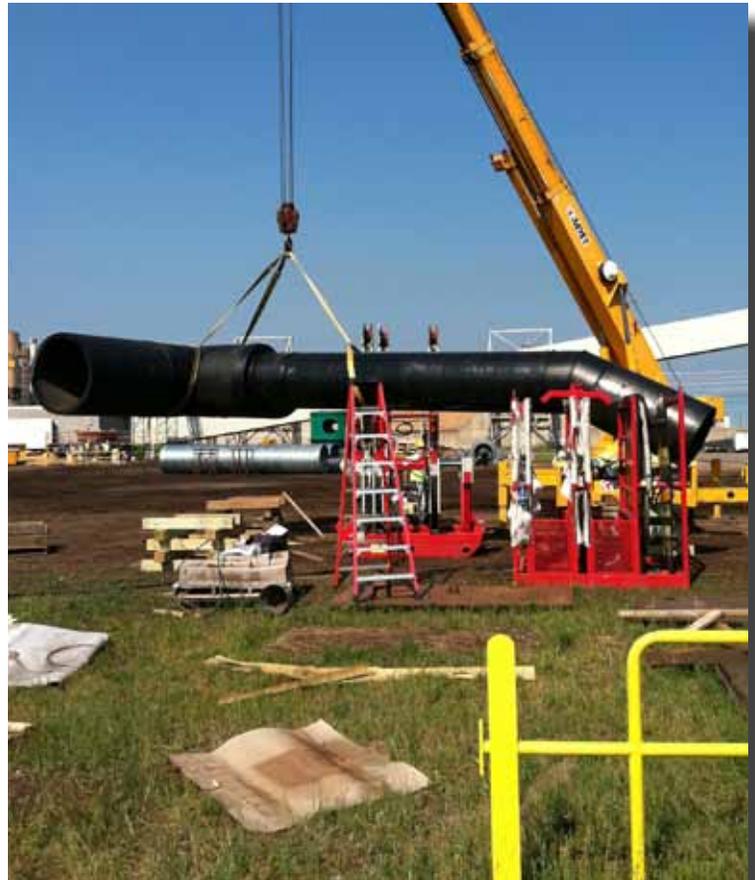
Another complex spool piece being moved during installation.

spaced and unique locations. Large cranes were used to move the large diameter pipe and fabricated spool pieces into the trenches for fusion to take place.
